Palo Verde Nuclear
Generating Station

**Subject: Palo Verde Nuclear Generating Station (PVNGS)
Unit 3
Docket No. STN 50-530
License No. NPF 74
Licensee Event Report 2008-001-01**

1. FACILITY NAME Palo Verde Nuclear Generating Station (PVNGS) Unit 3						2. DOCKET NUMBER 05000530		3. PAGE 1 OF 5			
4. TITLE Manual Reactor Trip when Removing a Degraded CEDM MG Set from Service

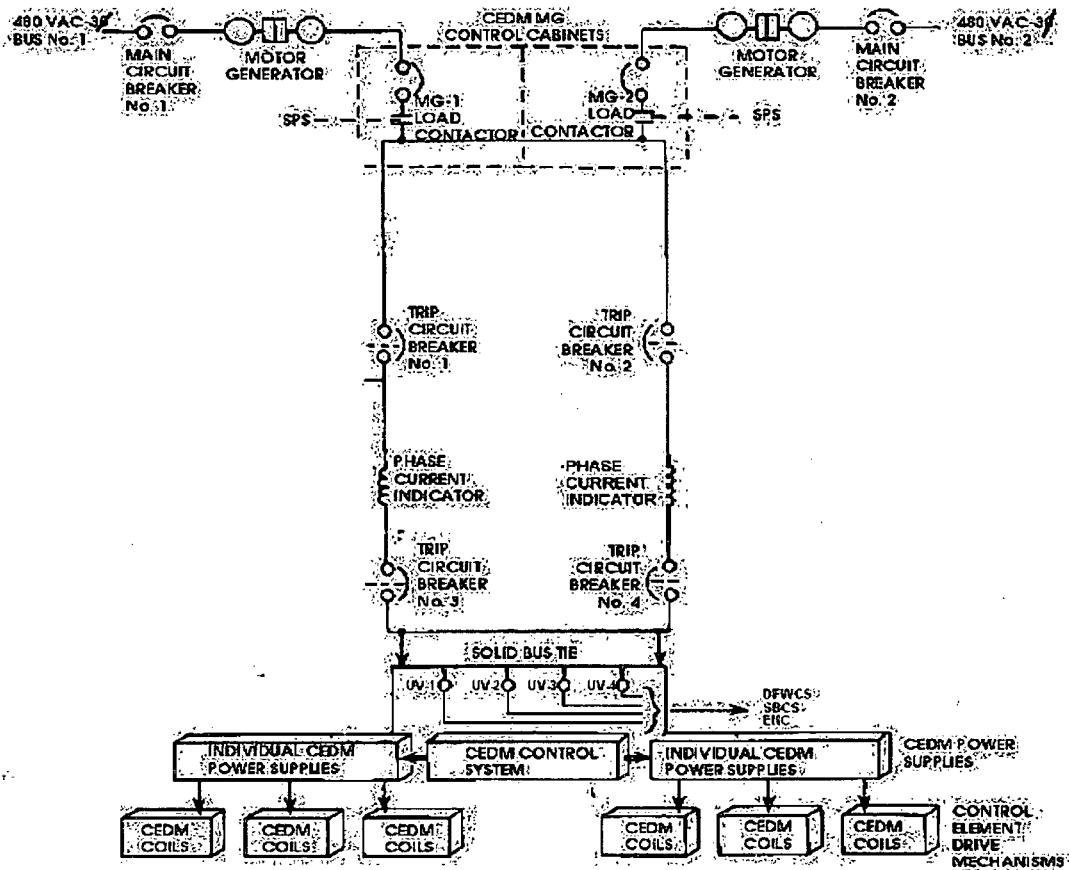
CEDM Bus Simplified

The two MG sets are connected in parallel to a common bus to supply 240 VAC, 3 phase power through two parallel sets of two reactor trip circuit breakers (see drawing on the last page). These four breakers and their controls make up the reactor trip switchgear (RTSG) (EIS Code: AA). The output from the RTSG is directed through circuit breakers for subgroups of CEAs and downstream individual CEA circuit breakers (EIS: 52) and then through power switch assemblies containing silicon controlled rectifiers (SCRs) converting the 3 phase, AC power to a smoothed DC output. This smoothed DC output is then divided and distributed throughout the CEDM cabinets for ultimate delivery to the CEDM coils for all 89 CEAs.
